Manhole Inspection Summary

Manhole # S11II1038MH

Insp Date: **5/24/07 2:51 PM**

Location Address: **4411 TOWANDA AVE**

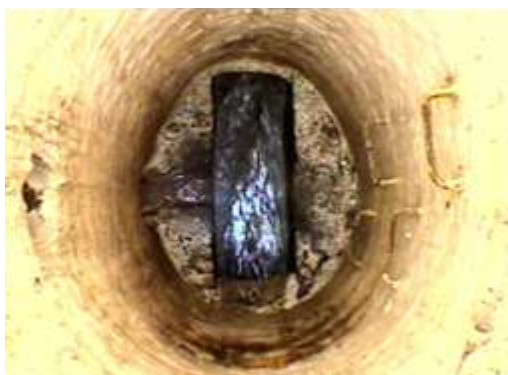
Defect 1

Count: **9** Missing: **0** ☒ **Corroded**

CORRODED STEPS

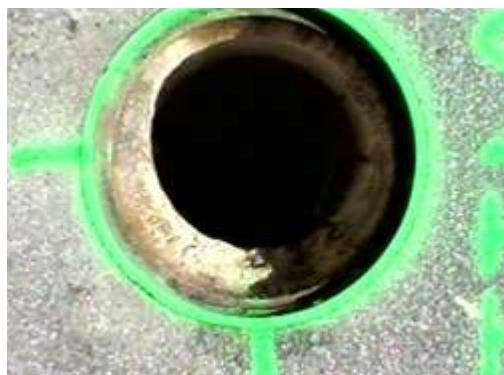
Defect 2

Offset: **3** (in.)

FRAME OFFSET

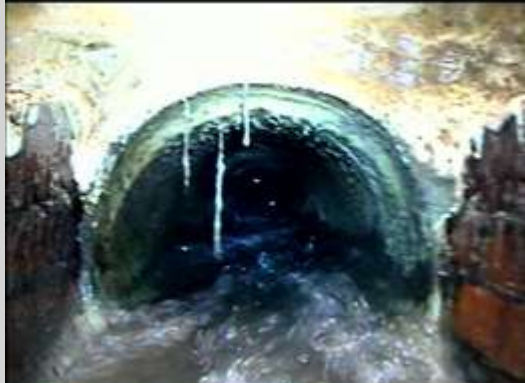
12 O'Clock Outflow

15 in. Circular Gravity Sewer
Pipe Out @ 12 O'Clock

Pipe Height: **15.6** (in.) Rod and Bar (Angled)
Pipe Material: **PVC** ☐ Pipe Lined
Invert Depth: **14.60** (ft.) Flow Characteristics: **Fast**
Deposits: ☒ None ☐ Mud ☐ Sludge ☐ Debris ☐ Grease
Silt Depth: (in.) Deposits Extent:
Infiltration: **None** Pipe Seal Cond: **Sound**

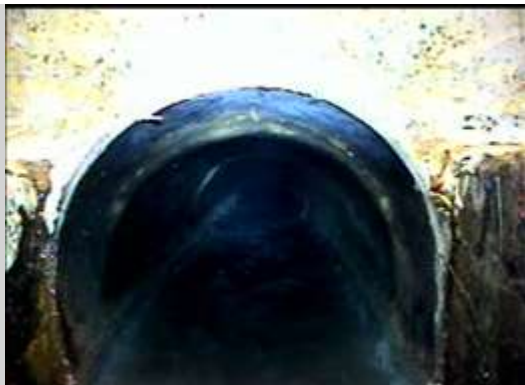
6 O'Clock Inflow

15 in. Circular Gravity Sewer
Pipe In @ 6 O'Clock

Pipe Height: **15.6** (in.) Rod and Bar (Angled)
Pipe Material: **PVC** ☐ Pipe Lined
Invert Depth: **14.55** (ft.) Flow Characteristics: **Fast**
Deposits: ☒ None ☐ Mud ☐ Sludge ☐ Debris ☐ Grease
Silt Depth: (in.) Deposits Extent:
Infiltration: **None** Pipe Seal Cond: **Sound**

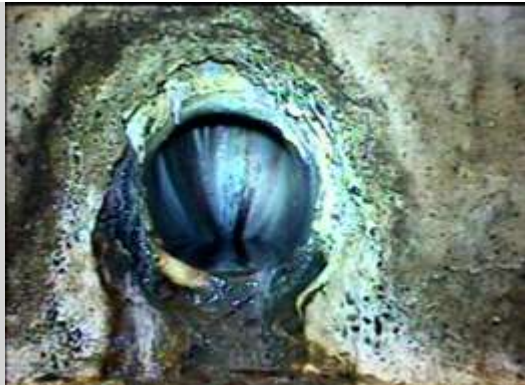
Pipe In @ 9 O'Clock

8 in. Circular Gravity Sewer

Pipe Height: **8.4** (in.) Rod and Bar (Angled)

Pipe Material: **Clay** ☐ Pipe Lined

Invert Depth: **8.00** (ft.) Flow Characteristics: **Slow**

Infiltration: **None** Pipe Seal Cond: **Sound**

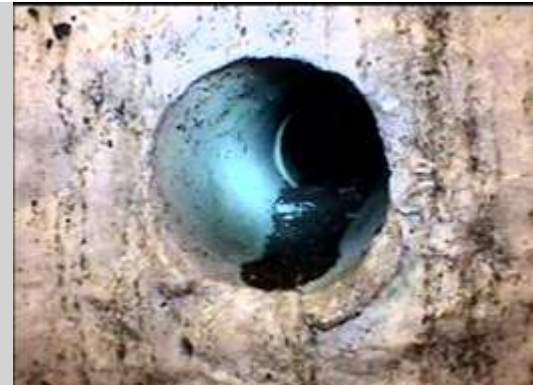
Drop In @ 9 O'Clock

Drop: **Outside** Rod and Bar

Angled: **Yes** Reading: **12.18** (ft.)

Inv Depth: **13.18** (ft.)

Drop Condition: **Open**
